Revista de Gestão Costeira Integrada

A methodology for the evaluation of evolution and risk of breakwaters. Application to Portimão harbor and of Faro-Olhão inlet

Rute Lemos^{@1}, Rui Capitão^{1,2}, Conceição Fortes^{1,3}, Maria Henriques^{1,4},
Luís Gabriel Silva^{1,5}, Tiago Martins^{1,6}

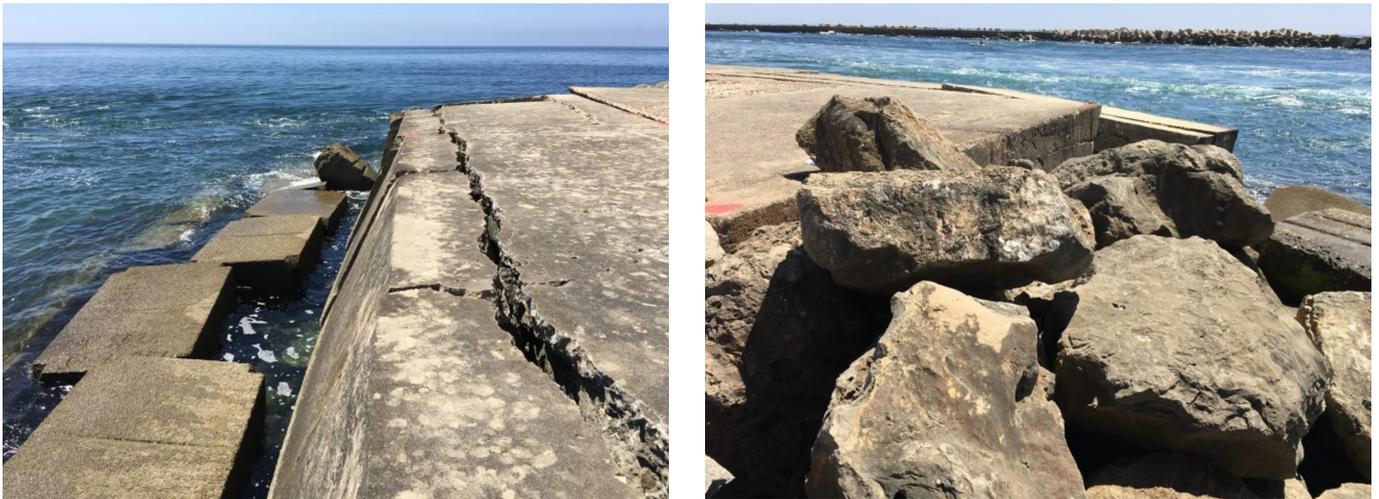
The west breakwater shows a number of damaged areas, namely at sections C and C1 (near the breakwater head), at point 12 (Figure 7a), and point 15 (Figure 7b), where one can see several cracks and settlements on the breakwater's slabs and units.

Figure 7. Faro-Olhão's west breakwater – Sections with problems: a) Point 12 (section C, inner layer); b) Point 15 (section C1, outer sector).

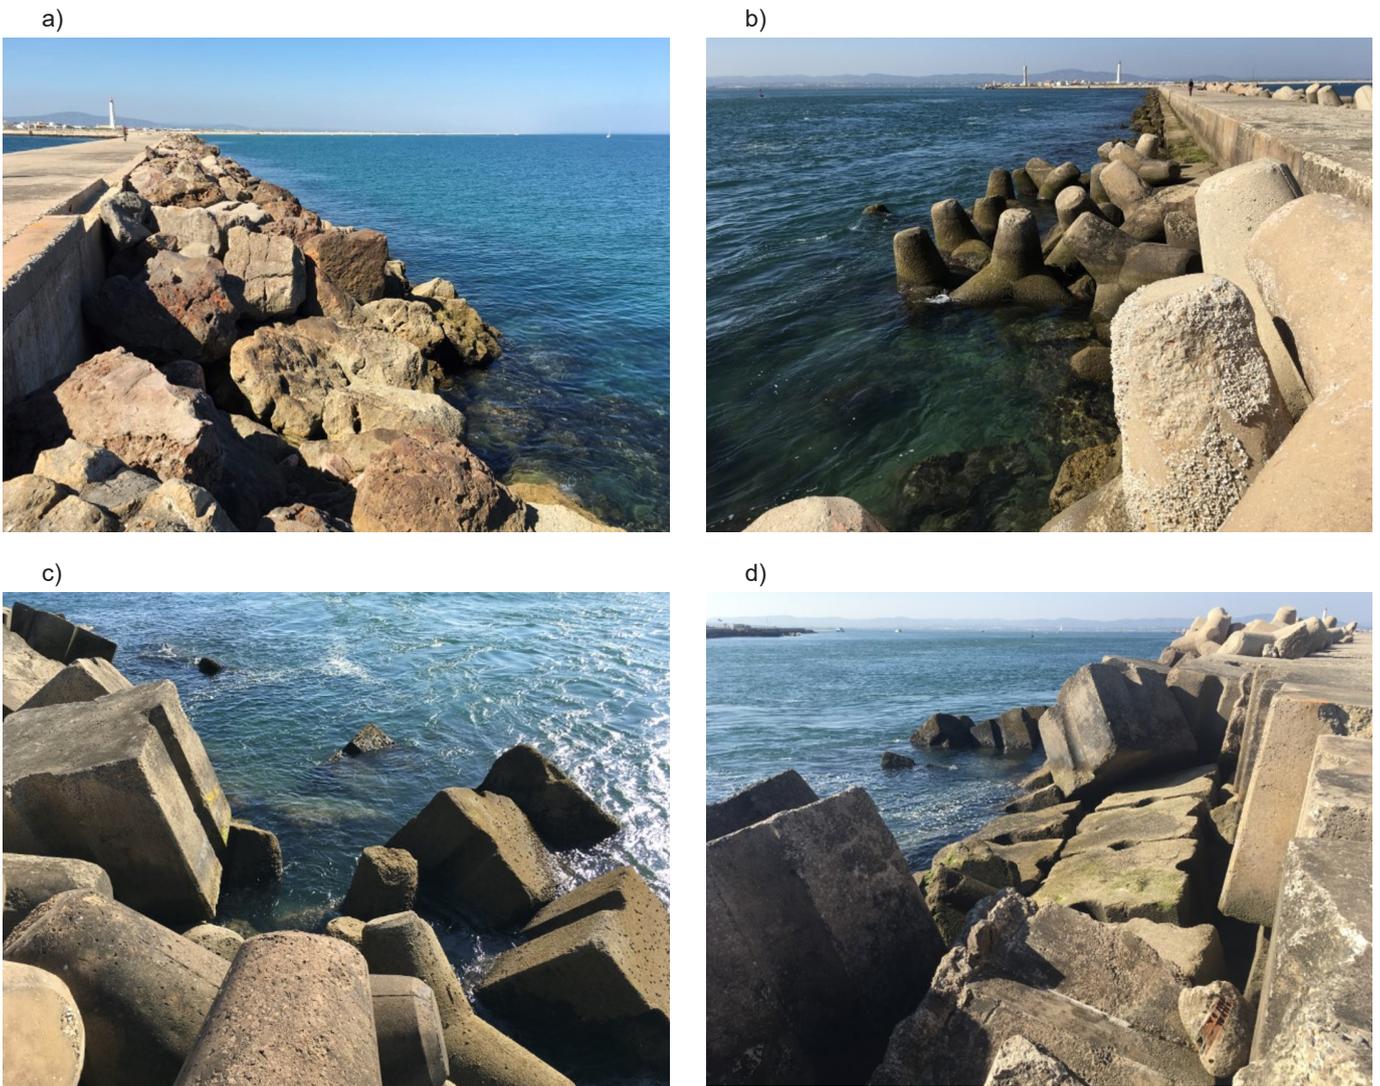
For the east breakwater, three sections (F, G and H) clearly show problems, with a number of damaged areas clearly visible, although the most damaged sections are the latter two.

The more relevant damages are located in section F, at several locations (see example in Figure 8a) for point 10), in section G, mainly its last part, covered with tetrapods (see example in Figure 8b) for point 19 and Figure 8c for point 22) and in section H, namely at the inner part of the breakwater head (see example in Figure 8d) for point 24). It is clear from previous observations, when compared with the present one, that some units of these three sections have been removed in the recent years.

Figure 8. Faro-Olhão's east breakwater – Sections with problems (see also Figure 5a): a) Point 10 (section F, exterior); b) Point 19 (section G, interior); c) Point 22 (section G, interior); d) Point 24 (section H, interior).

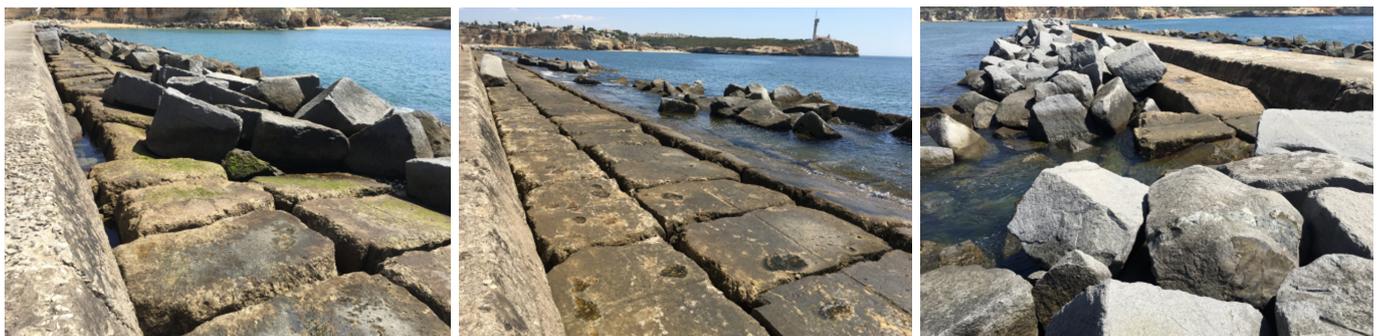
It was found that the east breakwater is somewhat damaged, especially in sections F and G (head). In particular, there are several degraded areas along the breakwater trunk, with visible block failures (resulting from falling / block movements).

Figure 11. Portimão east breakwater – Sections with problems: a) Point 5 (section E, lee side) b) Point 14 (section F, seaward side); c) Point 20 (section G – head, inner sector).

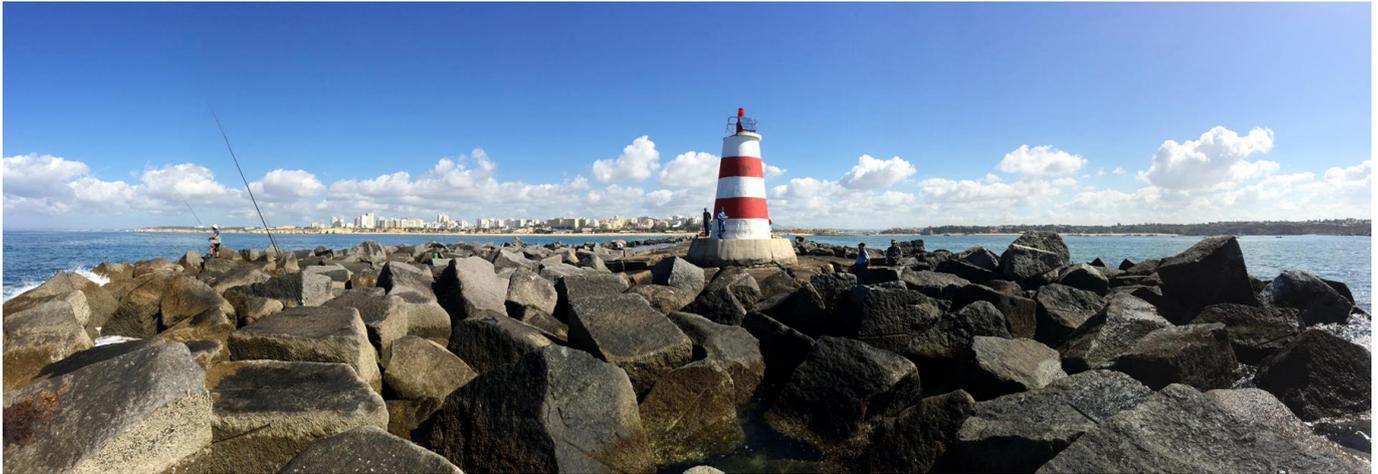
The west breakwater is globally in good conditions despite some damages, mainly in the quay (end of section A). It should also be noted that there has been a slight worsening of the inner slope condition of all breakwater trunk sections as well as its head area, especially in its inner sector.

Figure 12. Portimão west breakwater – Panoramic photo of section D (head).
