## REDUCING SEA CLIFFS HAZARDS IN POCKET BEACHES THROUGH BEACH NOURISHMENT ON THE BARLAVENTO COAST (ALGARVE, PORTUGAL)

Sebastião Braz Teixeira<sup>1</sup>

**ABSTRACT:** Tourism based on “sun and beach” is the main economic activity in the Algarve region. A considerable part of the beaches of the Barlavento coast corresponds to embedded sand accumulated along the irregular lacework-like coastline of rocky cliffs cut into Miocene calcarenites. The pattern of touristic occupation in the Algarve and the geodynamics of the rocky sea cliffs, characterized by discontinuous and intermittent occurrence of slope mass movements, result in a high level of risk to beach users along pocket beaches. In order to mitigate the risk associated with the cliff geodynamics, artificial beach nourishment was performed in Castelo and Coelha pocket beaches on the Barlavento Coast, in 2014, increasing the beach area by 3.5 times. The effects of the beach nourishment on the occupation patterns of those beaches along the 2006-2016 decade, before and after the beach nourishment, are herein presented and discussed. Occupancy data were obtained covering different seasons along the year, by counting the number o

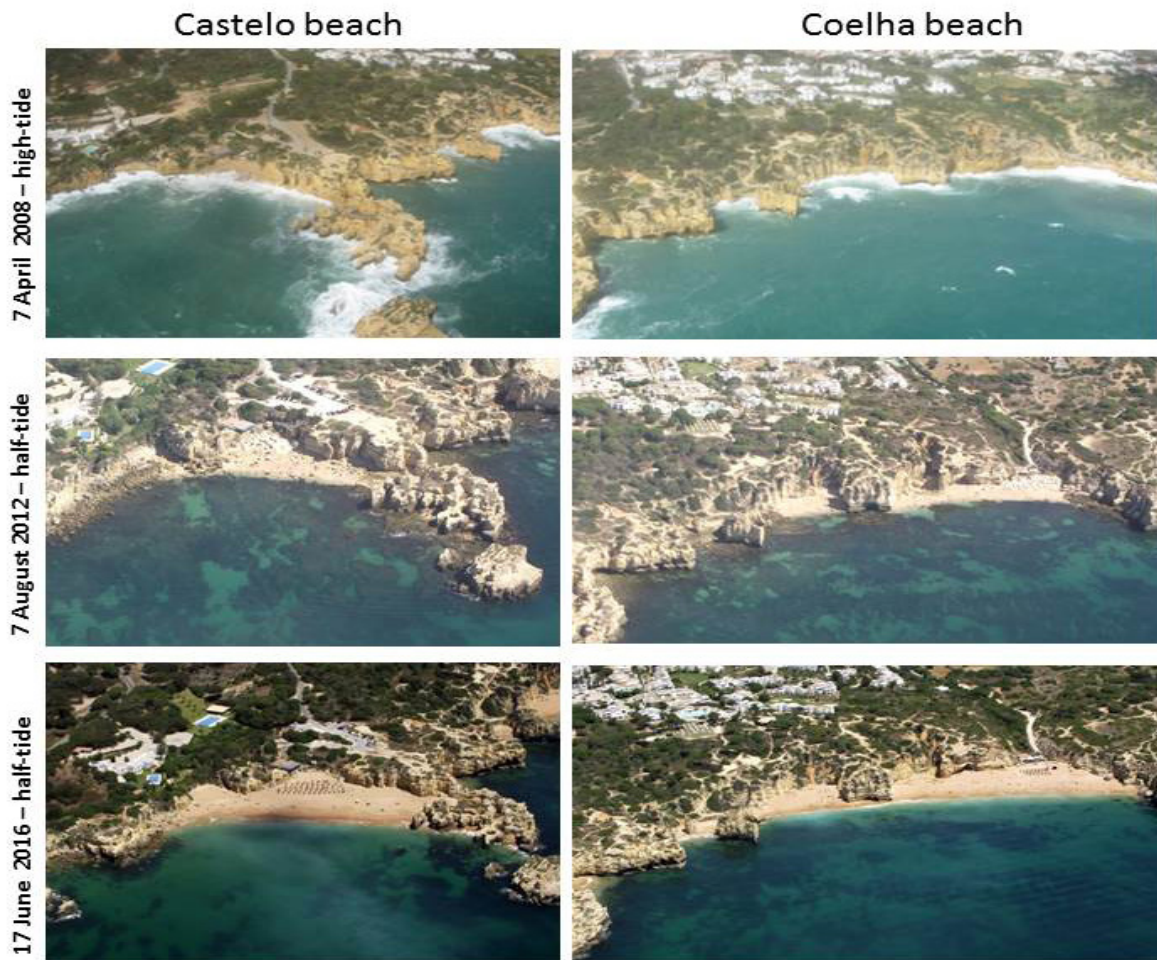
Figure 3. Castelo and Coelha beaches under storm conditions at high spring tide (7 Apr 2008, upper panel), under average summer wave conditions at half-tide before beach nourishment (7 Aug 2012, central panel) and under average summer wave conditions at half-tide after beach nourishment (17 Jun 2016, lower panel). Photos by the author.

and Coelha (Figure 1). These beaches, individualized by natural rocky headlands contain a thin sand cover accumulated over intertidal cut shore platforms. Under storm conditions coincident with spring tides, the swash sweeps the entire beach, reaching the toe of the cliffs (Figure 3).

Castelo beach is a small pocket beach (Figure 3) with a sea front of 150 m, and an average width of 20-25 m. Subvertical sea cliffs that limit the beach rise 12-15 m above the sand. Beach sediments are coarse sand  $D_{50} = 0.65 \phi$  (0.73 mm), with carbonate content of 30-50% (Teixeira, 2009). Coelha beach is a small pocket beach (200 m long) that accumulated in a recess of a hanging valley. The beach is supported by cliffs with heights of about 18 m. The Coelha beach sand texture is identical to the sand texture of the Castelo beach.

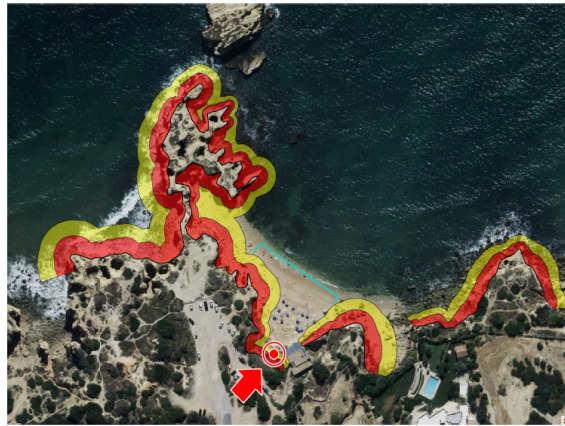
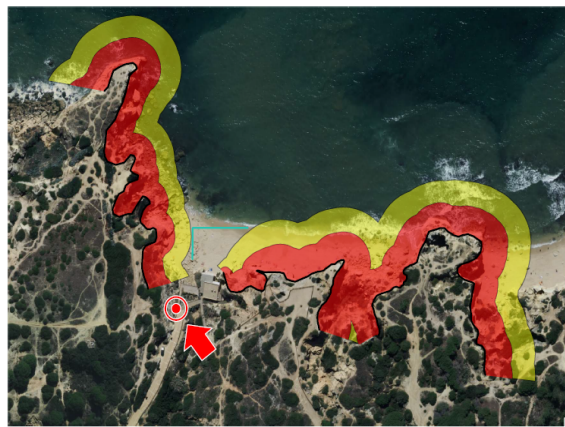
Natural cliff evolution (erosion) progresses by intermittent and discontinuous series of rockfall and cliff collapses. Cliff evolution is a potential menace for people standing on beaches accumulated at the cliff base. **HAZARD AREAS** correspond to areas where it is likely that effects of debris will be felt and its length reaches up to 1.5 times cliff height. The closer to the cliff is more likely to be hit by the collapse of a block. For your safety, keep away from cliff base and cliff edge, as well from sea stacks.

Figure 5. Sea cliff hazard signs of Castelo and Coelha beaches. Available at <http://www.apambiente.pt/index.php?ref=16&subref=7&sub2ref=10&sub3ref=923>.

Figure 5 reproduces the cartography resulting from this information on Castelo and Coelha beaches. Two hazard bands are identified: the red band (high hazard) corresponds to the area where, in the event of collapse, the probability of being hit by the rock debris is greater than 50 %. The yellow band (moderate hazard) covers the area where the probability of being struck by the debris is less than 50 %. In the remaining area of the beach not covered by the two ranges the probability of being hit by debris of any mass movement is less than 5 % (low hazard).

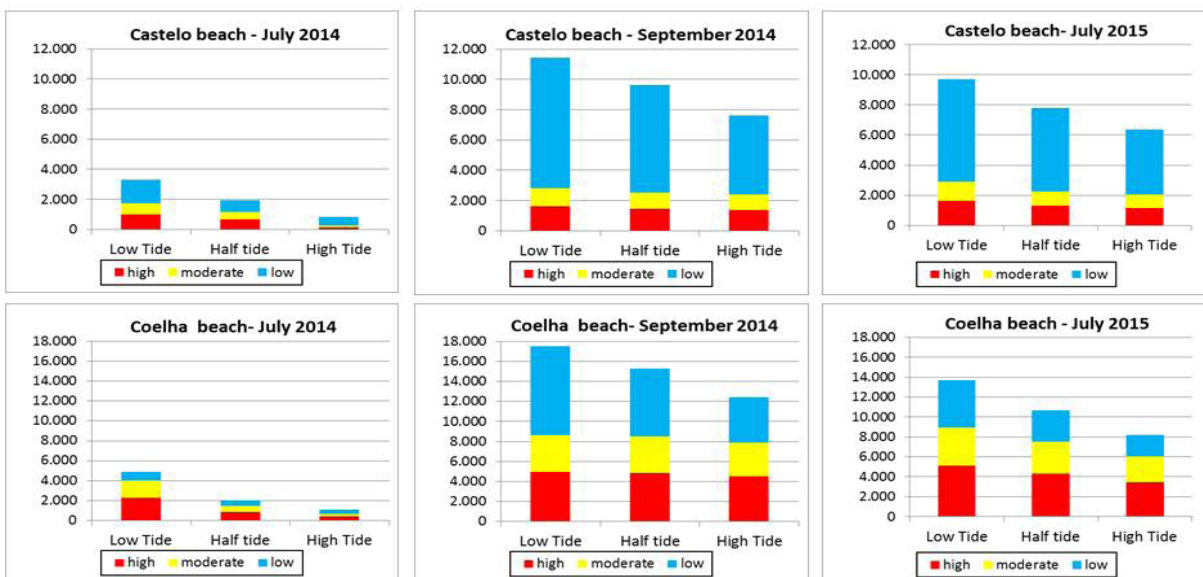
Figure 6. Dry beach area (m<sup>2</sup>), before beach nourishment (left panel), after beach nourishment (central panel) and one year after beach nourishment (right panel), depending on the state of the tide, under average summer wave conditions: average low tide, half- tide and average high tide. Dry beach areas (m<sup>2</sup>) on the high hazard zone (red), moderate hazard zone (yellow) and low hazard zone (blue).

Beach nourishment of the Castelo and Coelha beaches provided a very significant increase in the dry beach area available for beach users (fig.6). The beach area above the MSL increased about 3.5 times on both beaches. One year after nourishment, Castelo beach lost 15 % and Coelha beach lost 22% of the sand initially deposited. These values are in agreement with records and reports from other artificial nourishments in the subaerial zone in the Algarve region and that reach up to 25 % initial losses (Teixeira, 2011, 2016).

The results show that most of the dry beach was included in the maximum and moderate hazard areas before beach nourishment, due to the small width of the original beaches (Fig. 6), indicating that their users were only safeguarded from this danger when bathing. In Coelha beach the area available to users in the low hazard area was always very small, not exceeding 830 m<sup>2</sup> during low tide. After beach nourishment, the dry beach area in the low hazard area was 8900 m<sup>2</sup>, decreasing to 4800 m<sup>2</sup> one year after the works. At Castelo beach the low hazard area was 1600 m<sup>2</sup> before the beach nourishment, increased to 8600 m<sup>2</sup> after the intervention and remained at 6800 m<sup>2</sup> one year later. Results are more expressive in average high tide conditions. In Coelha beach the area available in the low hazard area was 430 m<sup>2</sup>, increased to 4500 m<sup>2</sup> after the intervention and remained at 2150 m<sup>2</sup> one year after the intervention. In Castelo beach, these values were, respectively 580 m<sup>2</sup>, 5200 m<sup>2</sup> and 4300 m<sup>2</sup>. These figures show that the beach area outside the high and moderate hazard areas increased very significantly on both beaches.

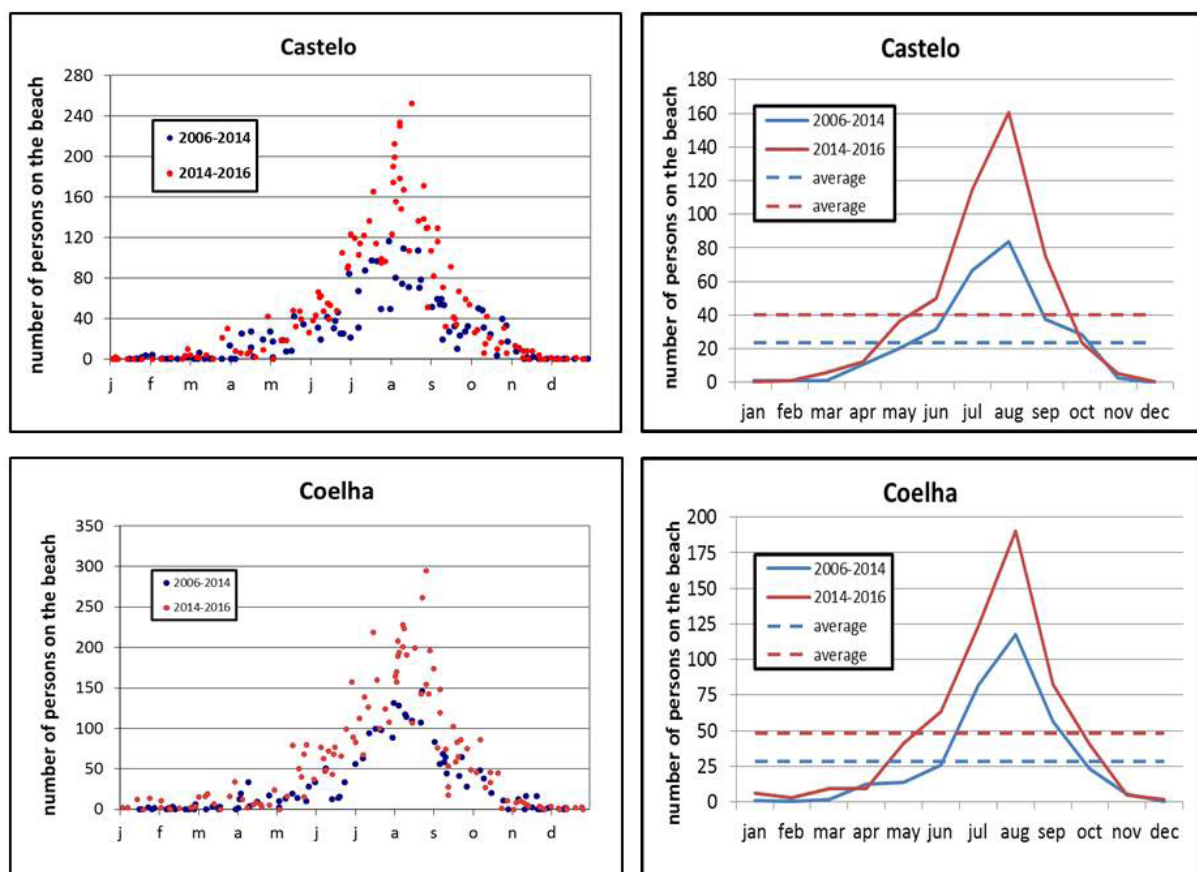
Figure 7. Annual beach occupancy data between the decade 2006 and 2016, before (2006-2014) and after (2014-2016) beach nourishment. Daily (left panel) and monthly average (right panel) beach occupation.

As expected, the pattern of occupation on the two beaches presents a strong seasonal component, accompanying the annual variation of temperature and tourist activity. The peak of occupancy on both beaches is concentrated in the month of August which is the month of greatest tourist demand in the region (Figure 7).

The results of the annual distribution of occupation in the two beaches (Figure 7) show that in the period after the beach nourishment, there was a very significant increase in the demand for the beach in the period between May and October. On average, the annual increase in occupancy was 68 % in Castelo beach and 69 % in Coelha beach. These figures can only be attributed to the increase of the available beach area on both beaches.

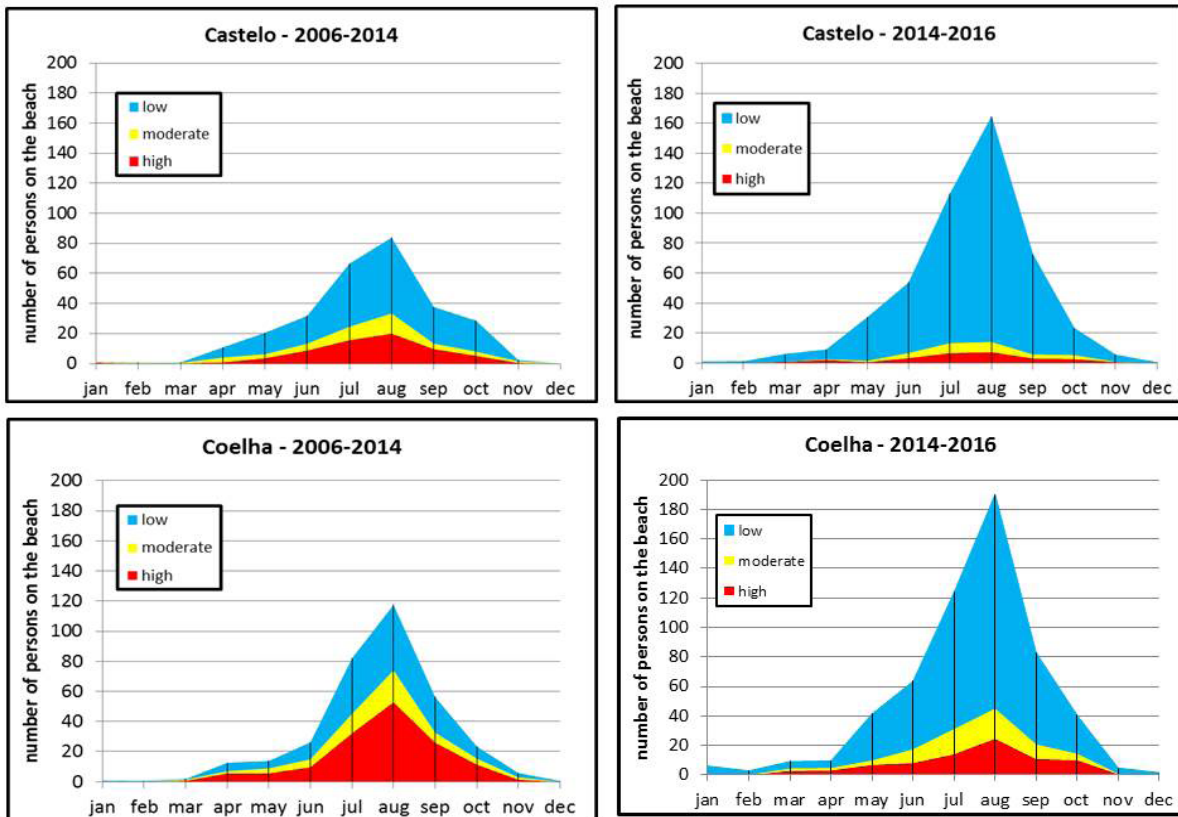
Figure 8. Monthly average beach occupation distributed by high (red), moderate (yellow) and low (blue) hazard areas, before (left panel) and after (right panel) beach nourishment.

Figure 8 summarizes the annual distribution (with monthly average values) of the occupation of the three hazard areas (high-red, moderate-yellow and low-blue) in the periods before and after the beach nourishment on Castelo and Coelha beaches.

At Castelo beach, the change in the pattern of occupancy of the hazard areas is noticeable, with a very significant decrease in the occupation of high and moderate hazard areas (fig. 8). The annual average was 37 % of users located in those areas in the period before beach nourishment, reducing to 11 % after the nourishment project. This result should be attributed to the increase in available dry beach and consequent relocation of the users from the toe of the cliffs towards the water plan.
