Revista de Gestão Costeira Integrada

A methodology for the evaluation of evolution and risk of breakwaters. Application to Portimão harbor and of Faro-Olhão inlet

Rute Lemos^{@1}, Rui Capitão^{1,2}, Conceição Fortes^{1,3}, Maria Henriques^{1,4},
Luís Gabriel Silva^{1,5}, Tiago Martins^{1,6}

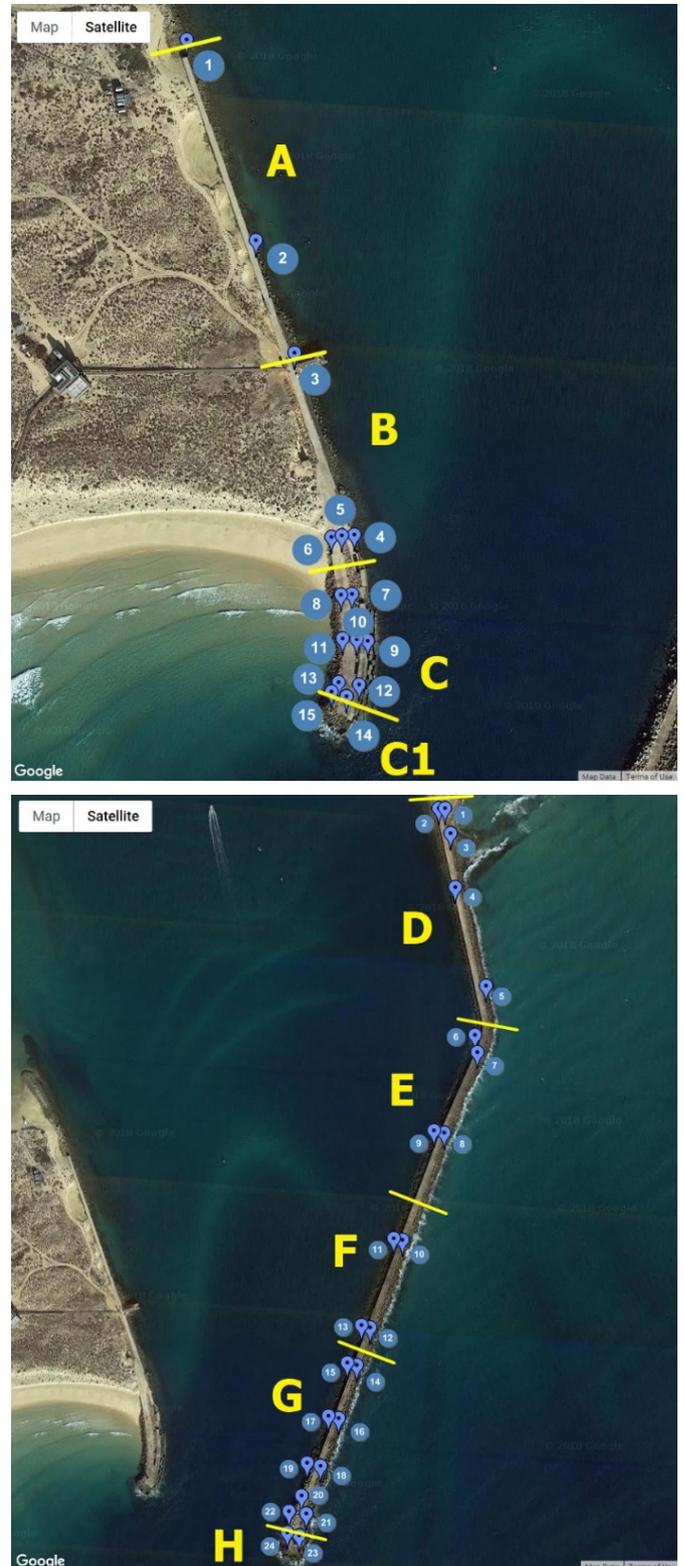
Figure 5 illustrates the four sections of Faro-Olhão's breakwaters for the west breakwater (A, B, C and C1), and the five sections for the east breakwater (D, E, F, G and H). Figure 6a) and Figure 6b) show photographs taken at a predefined point of Faro-Olhão's east breakwater (point 19, located in the inner part of section G), according to the southwest and northeast approximate directions, respectively.

Figure 5. Faro-Olhão's breakwaters with division into sections and visual observational points: a) west breakwater, sections A to C1; b) east breakwater, sections D to H.

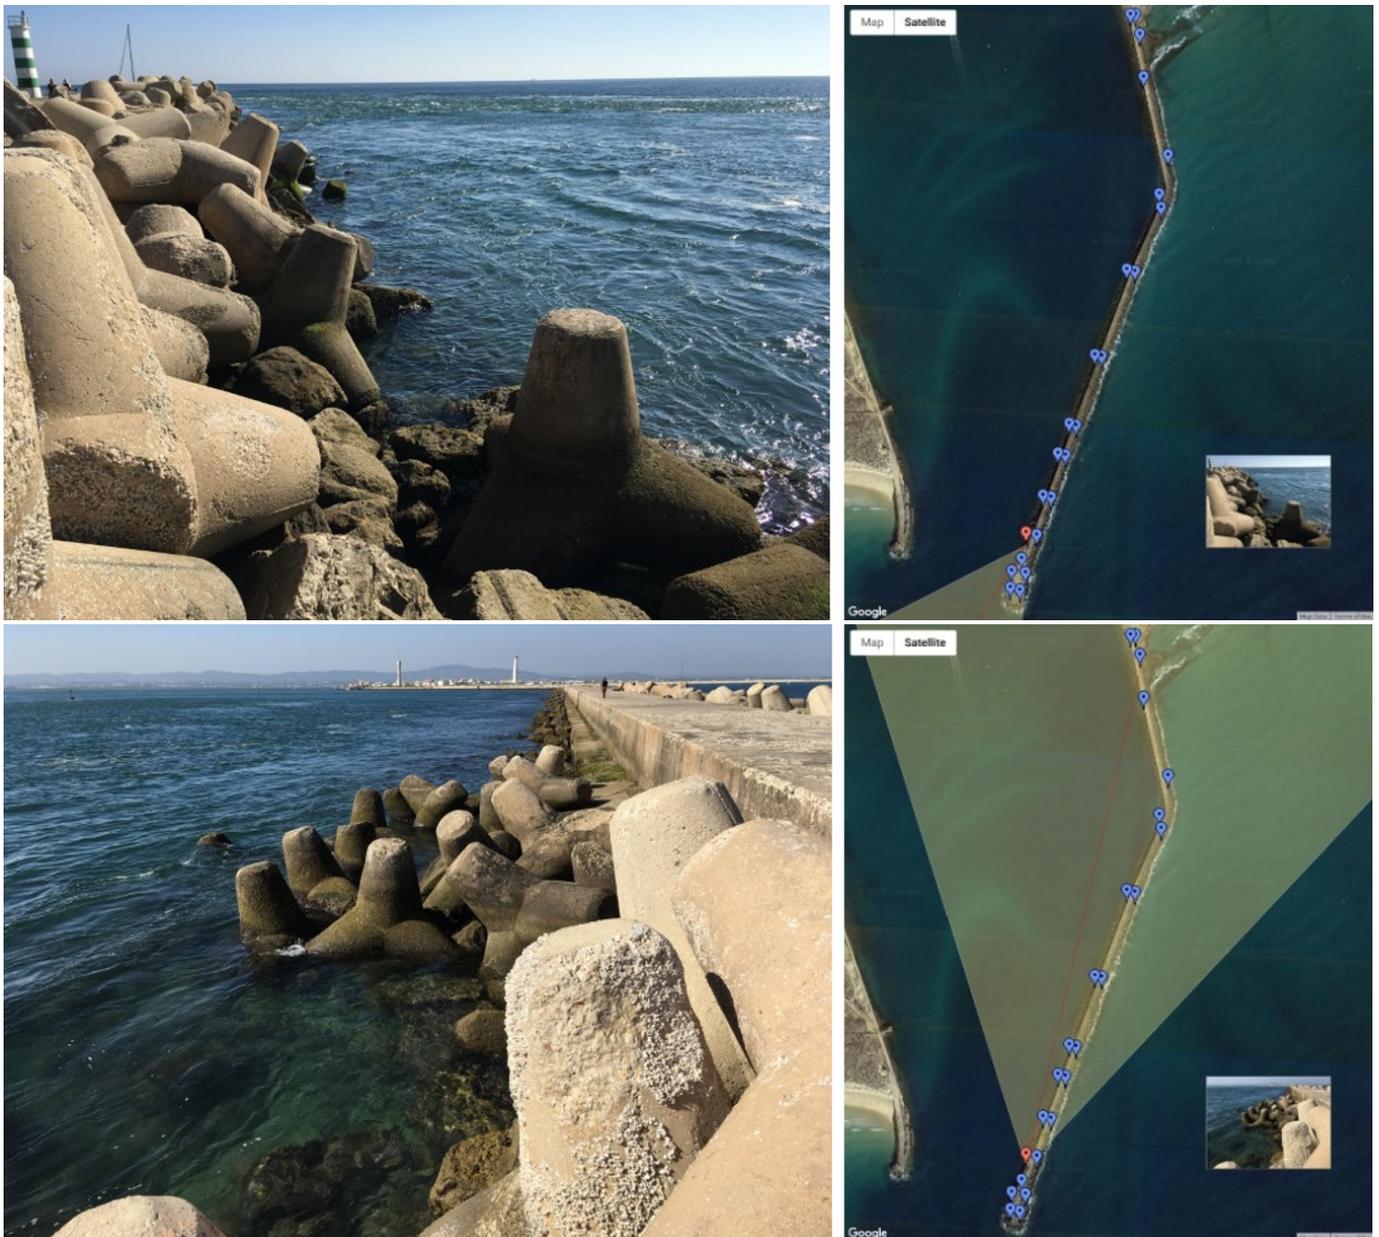
Figure 6. Systematic photographs taken at predefined points. Case of Faro-Olhão's east breakwater, point 19, according to two predefined directions: a) southwest; b) northeast.

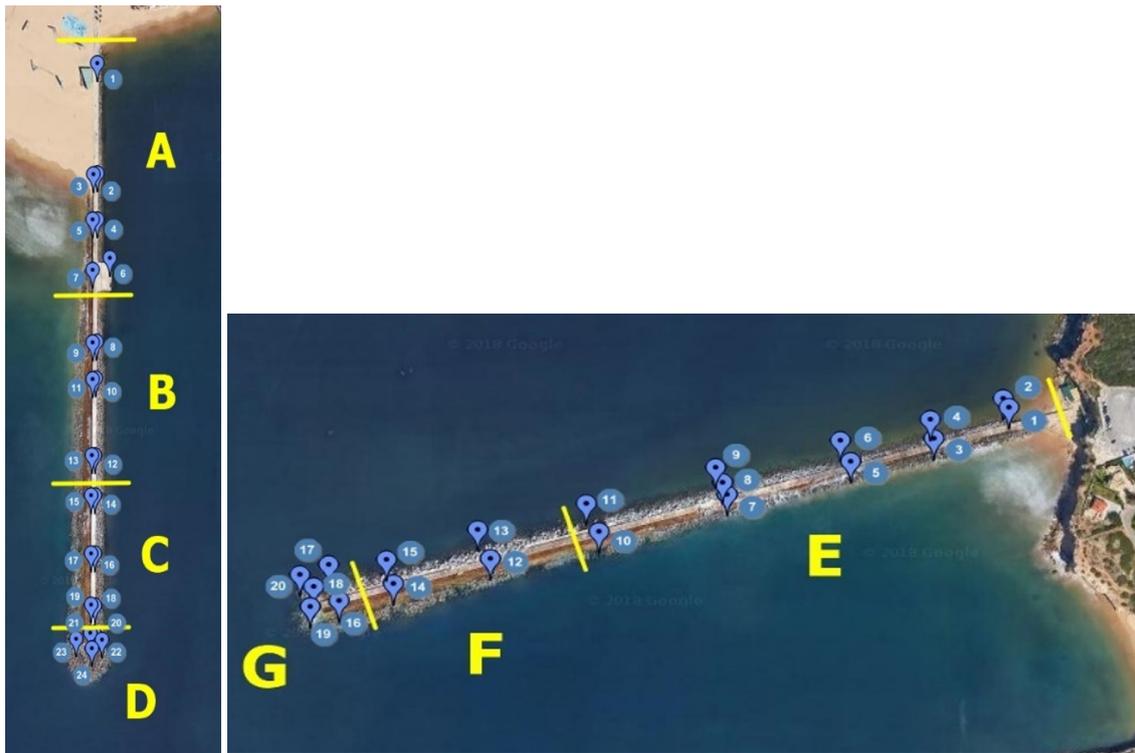
Figure 9 illustrates the four sections of Portimão's west breakwater (A, B, C and D), and the three sections for the east breakwater (E, F and G).

Figure 9. Portimão breakwaters with division into sections and visual observational points: west breakwater, sections A to D (left); east breakwater, sections E to G (right).

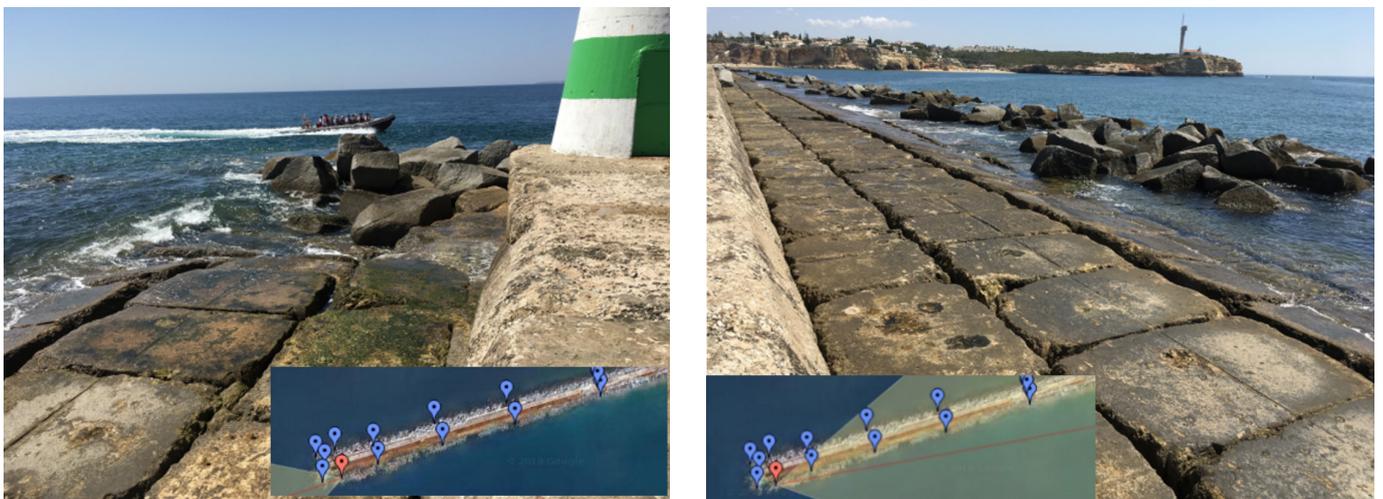
Figure 10a) and Figure 10b) show photographs taken at a predefined point of Portimão's east breakwater (point 16, located in the exterior part of section G), according to the seaward and landward directions, respectively.

It was found that the east breakwater is somewhat damaged, especially in sections F and G (head). In particular, there are several degraded areas along the breakwater trunk, with visible block failures (resulting from falling / block movements).

Figure 10. Systematic photographs taken at predefined points. Case of Portimão east breakwater, section G (head), point 16, according to two predefined directions: a) seaward direction; b) landward direction.

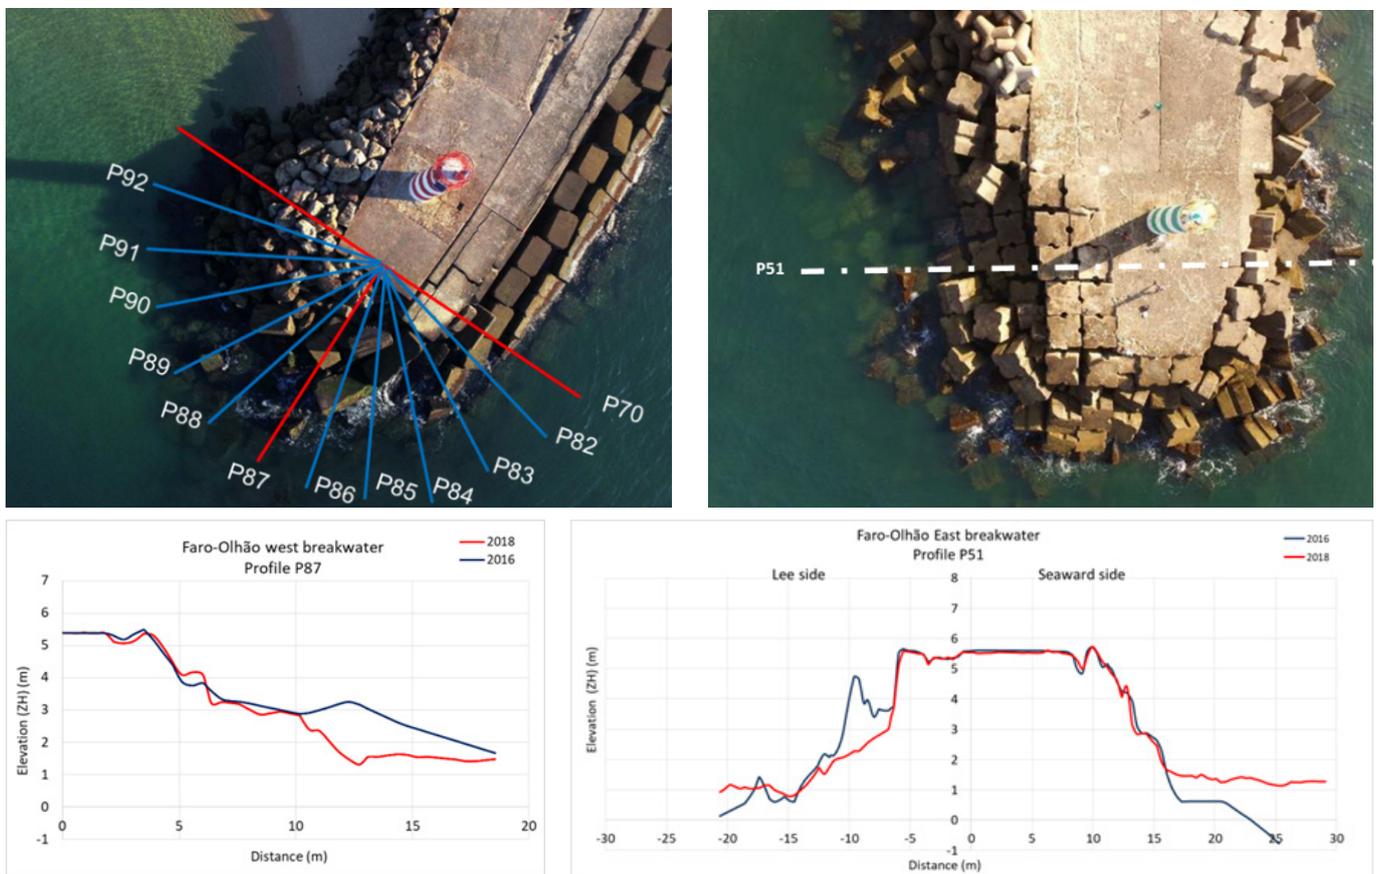
Figure 18 shows the contour maps generated from the point clouds for the west and east breakwaters. Also, profiles at more vulnerable points of the structure may be produced: see Figure 19 for an example of two profiles comprising the current campaign (2018) as well as a previous campaign conducted in 2016. Profile 87 differences show an eroded depth of around 2 m (approximately the nominal diameter of an armour unit). To monitor the breakwater evolution, point clouds of different campaigns may be compared and areas and volumes of changed sections may be computed.

Figure 19. Profiles of vulnerable sections of Faro-Olhão's breakwaters for campaigns of July 2018 25th and 26th. West breakwater (left) and east breakwater (right).

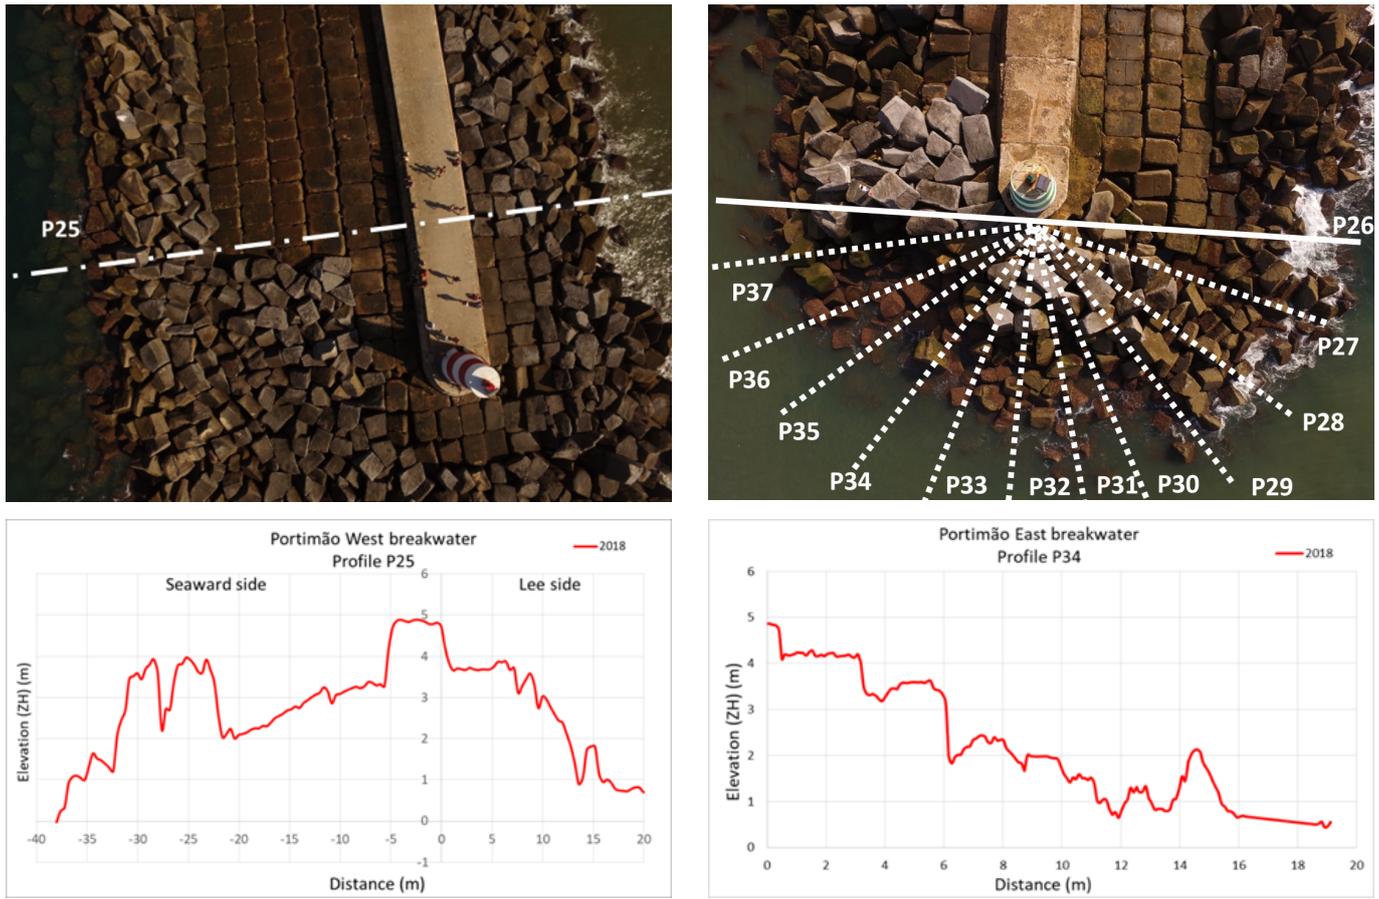
Figure 23. Profiles of vulnerable sections of Portimão breakwaters for campaigns of July 2018 25th and 26th. West breakwater (left) and east breakwater (right).
